Report # / I.D : Samp070612

Inspection Date : July 12 2012

Property Address : 411 Circle Caviar, Murrieta, Ca, 92562

Type Of Inspection: Pre-Purchase Inspection

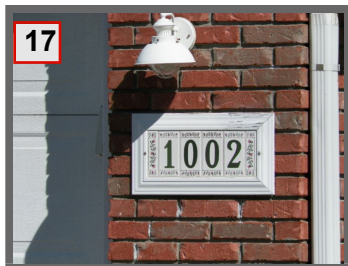
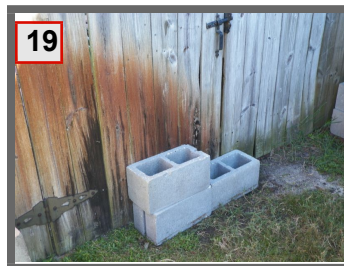
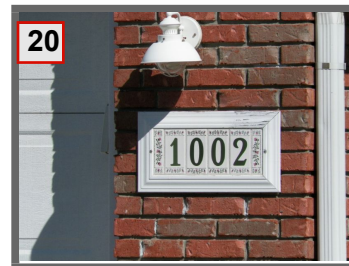
Surface Grade: Lot drainage is flat or slopes toward the house at rear.

Loose / leaning / gaps & there is potential for small pets to escape.

Sidewalks: Small / moderate cracks noted. No adjacent damage found.

Recommended evaluation by a licensed structural engineer / Geotechnical engineer.

Surface Grade: Recommend installing window wells & or covers at basement windows.

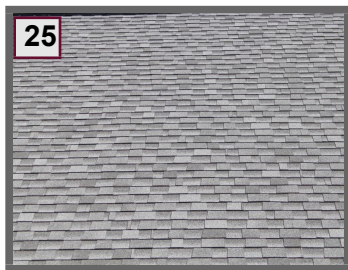
Shingles need secured & sealed at one or more locations.

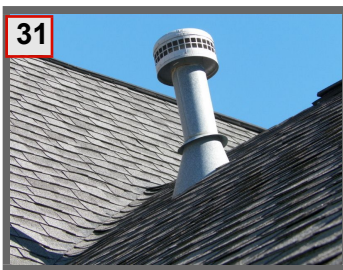
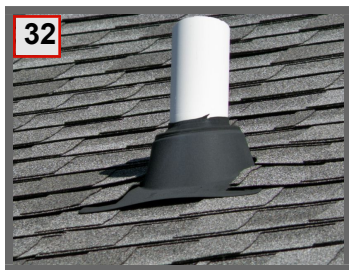
Wire in over hang

Main Roof: Cracked / broken / displaced shingle found. (2)

Main Roof: Recommend removal of vegetation from eaves / roof surfaces / edges. (2)

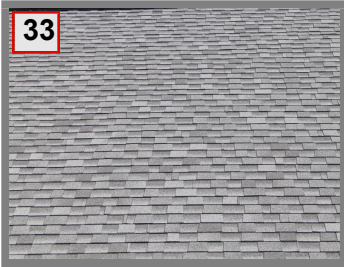
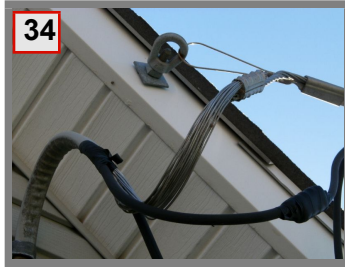
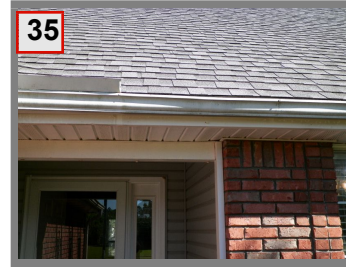
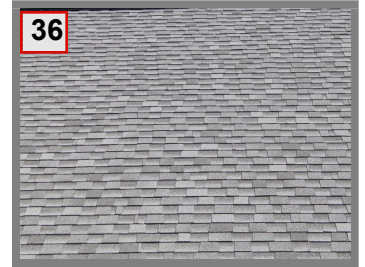
Main Roof: Active roof leak found at: *** (2)

Main Roof Comment: Recommend roofing evaluation / repair due to several areas of cracked / loose / deteriorated / missing mastic / sealant around vents / joints / edges. (2)

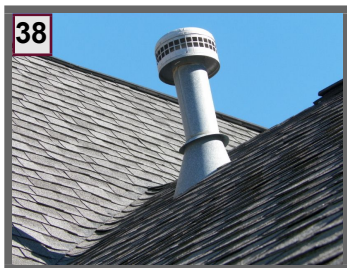
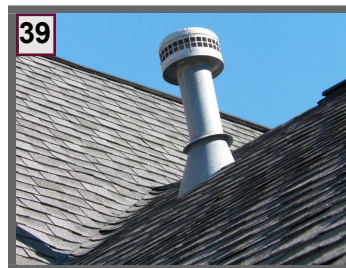
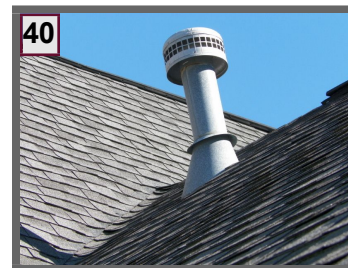
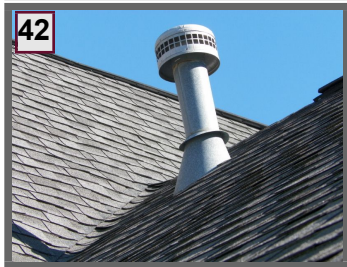
Chimney / Fireplace: Keep in mind that the fireplace is a direct vent unit & the chimney is at the porch/patio area/deck. This poses a possible safety concern since it gets very hot when fireplace is in use. Be sure not to touch or keep items stored close to the chimney.

Chimney: Flashing requires repair / resealing where chimney penetrates the roof surface. (2)

Chimney: Recommend evaluation by a qualified specialist to determine if the spark arrester / shroud are approved / listed for use with this fireplace & chimney. (2)
