Report # / I.D: Samp070612

Inspection Date: July 12 2012 Time: 9am

Property Address: 411 Circle Caviar Murrieta, Ca, 92562

Type Of Inspection: Pre-Purchase Inspection Home Type / Style: Single Family Home

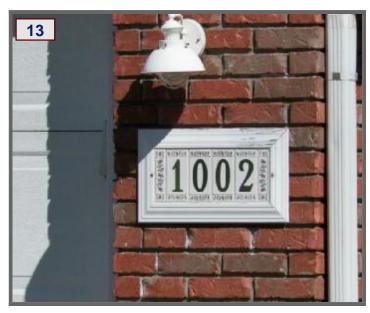
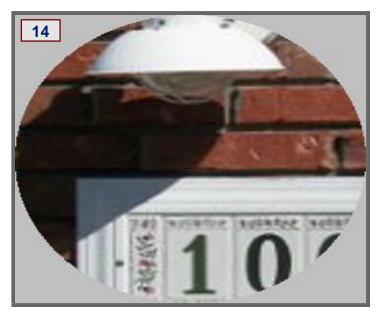
Rear Gate and Fence Damaged and leaning, at end of life, Noted Earth to wood contact. (2) See Photo # 3 Front Light Cover Missing See Photo # 1, 2

Front Light Bulb missing

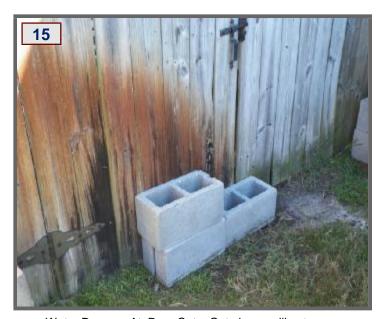
Water Damage At: Rear Gate, Gate loose will not open.

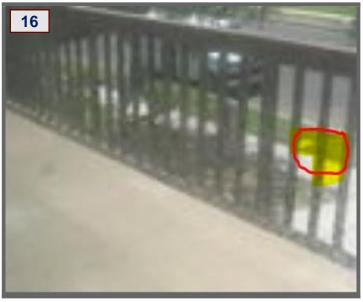
Unable to fully evaluate exterior, grounds, and drainage components due to the presence of frozen ground, snow, & ice. Patio / Porch / Balcony: Railing spacing exceeds 4 inch maximum required in new construction. Recommend upgrading to provide enhanced safety for children / pets. (5) See Photo # 16

View of Exterior railing opening 7-8 inch

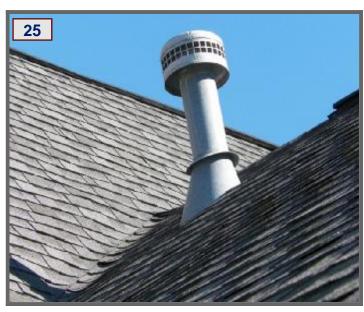
Shingles need secured & sealed at one or more locations.

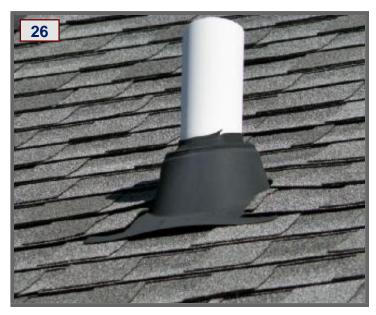
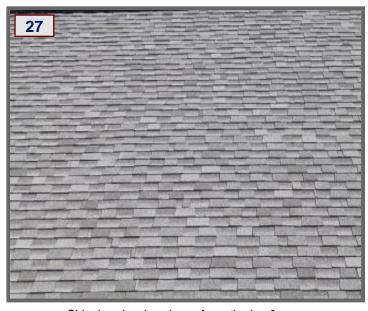
Main Roof: Deteriorated / damaged shingles. (2)

Shingles showing signs of weathering & age.

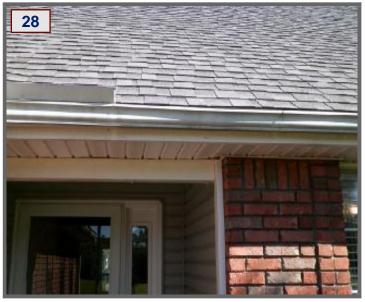
Gutters / Downspouts: Loose / damaged / missing gutters / downspouts noted at: Several Areas, See Photos 28 Downspouts: No gutter system provided. At Rear and Sides of RoofClient should consider installing gutters & properly directed downspouts as an to help prevent flooding / property damage. (5)

Gutters Damaged and lose.

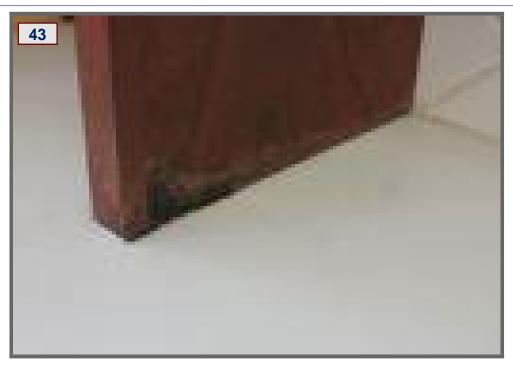
Hall: Interior doors have a water damaged (2) See Photo # 43 Master Bedroom: Broken window glass (2) See Photo # 44

Hall Entry Door Water stain

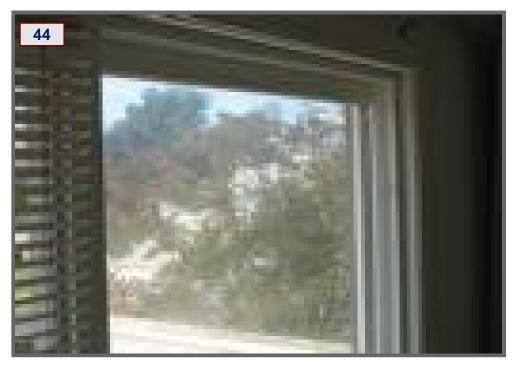
View of broken window glass at Master bedroom

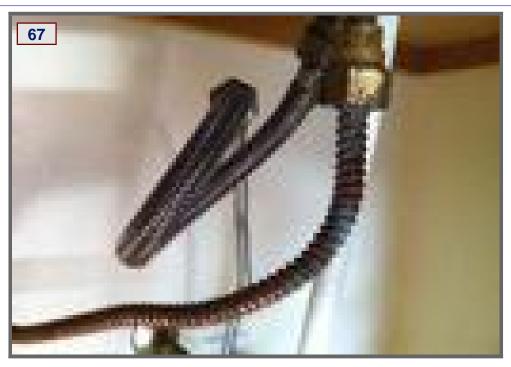
Master Bathroom Signs of past leaks/corrosion at drain lines under sinks. Noted Micro leek (2) See Photo # 67

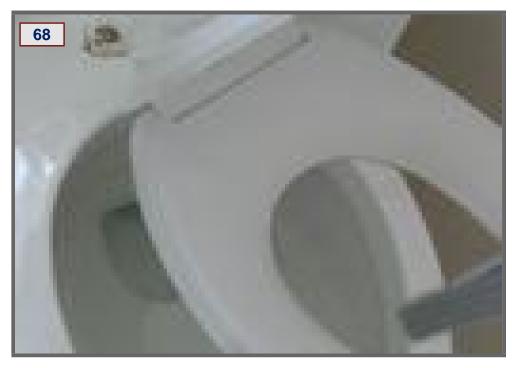
Master Bathroom Toilet: Seat Needs Adjustment / repair required to Operate properly (2) See Photo # 68
