Report # / I.D : Inspection Date : Client Name : Property Address : Dell06132015 June 13 2015 Time : 1:30 Donald Dell 1121 Any Street La Jolla, Ca 92038

# Re Inspected On 06/21/2015 All Previous Defects Confirmed

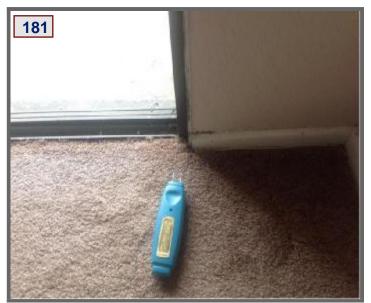
Right side of Sliding Door Moisture Noted (2)

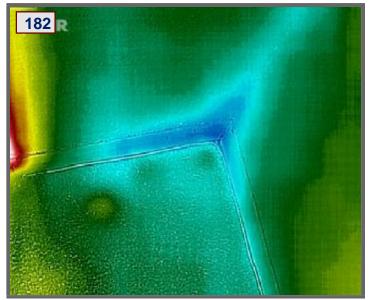
Right side of Sliding Door Moisture Noted (2)

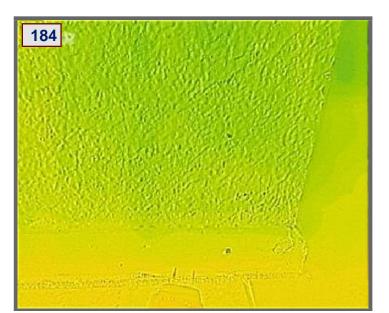
Ceiling Repaired in Bedroom 1 No Moisture Noted

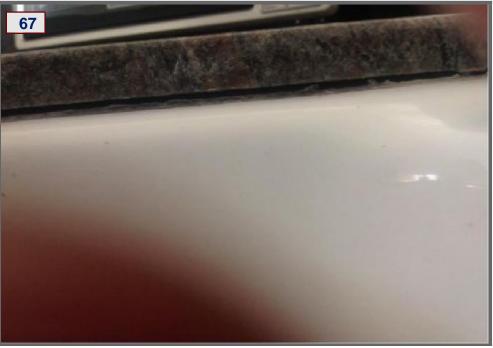
#### Gap at Kitchen and Garnet

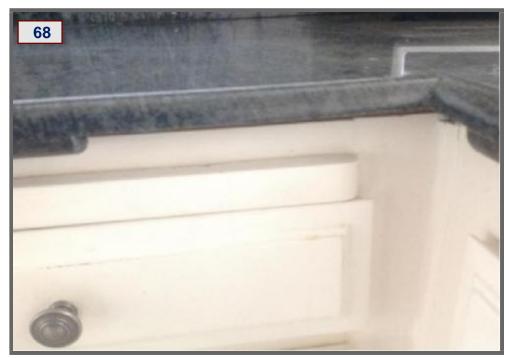
Damaged Garnet at next to Kitchen Sink

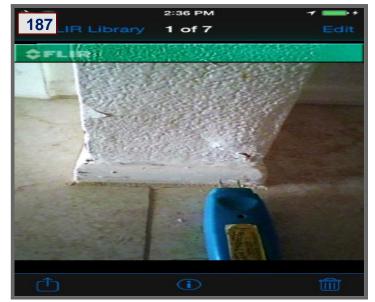
Kitchen Moisture Noted in Several Areas

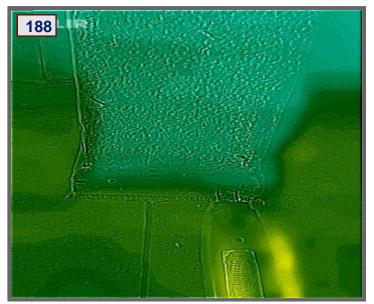
Kitchen Moisture Noted in Several Areas

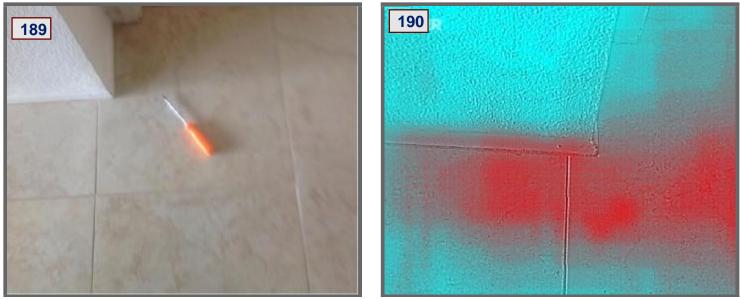
Loose Tile And Moisture Noted

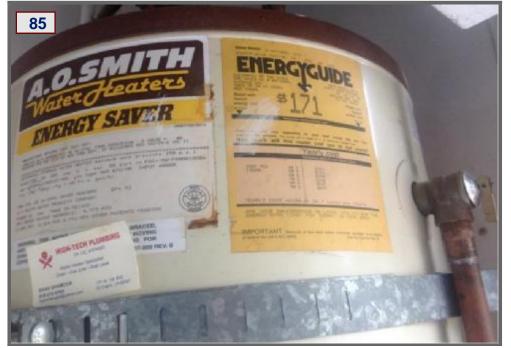
Water Heater: May be at end of life, Makes popping sound when turned on to test. See Photo # 85 Water Heater: Hot Water Heater Shut off Valve Corroded . See Photo # 86

#### Hot Water Heater Rusted

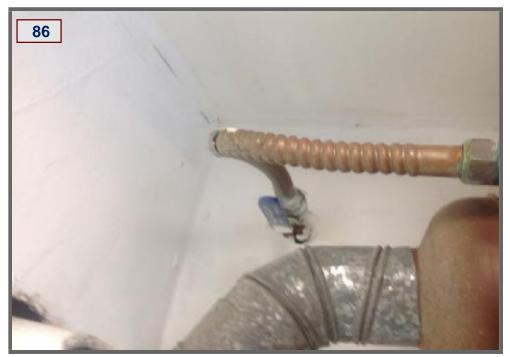
Hot Water Heater Shut off Valve Corroded

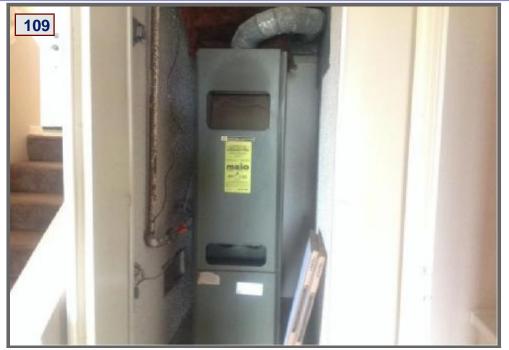
#### Heater Located in Closet

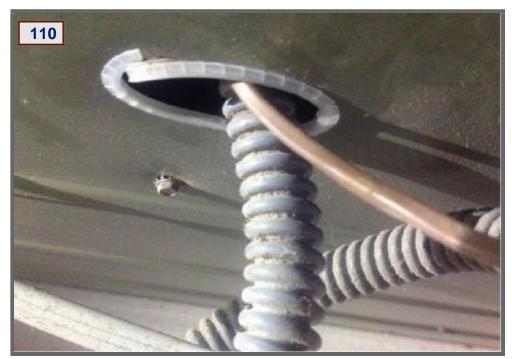
Gas Line In Properly Installed

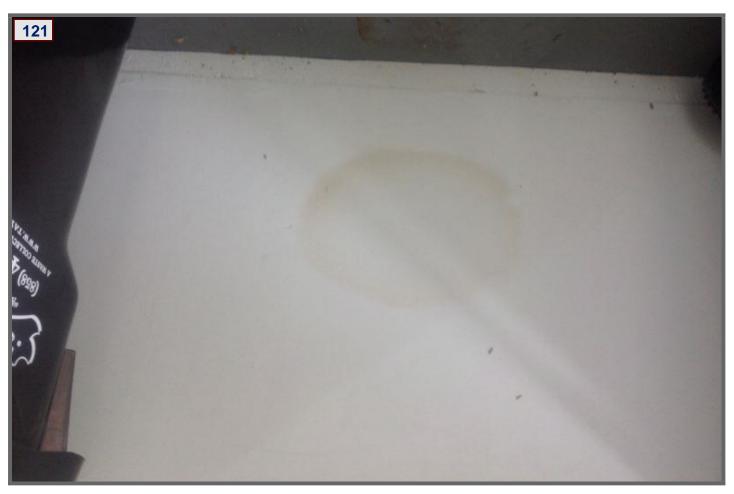
Water Stain
