Report # / I.D : Dell06132015
Inspection Date : June 13 2015 **Time :** 1:30
Client Name : Donald Dell
Property Address : 1121 Any Street La Jolla, Ca 92038

Re Inspected On 06/21/2015 All Previous Defects Confirmed

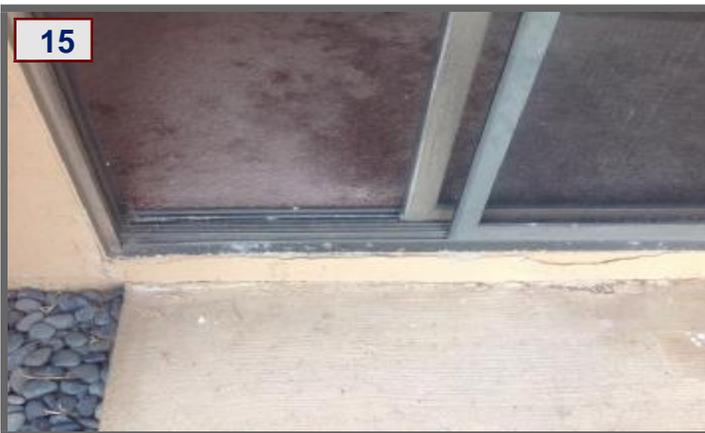
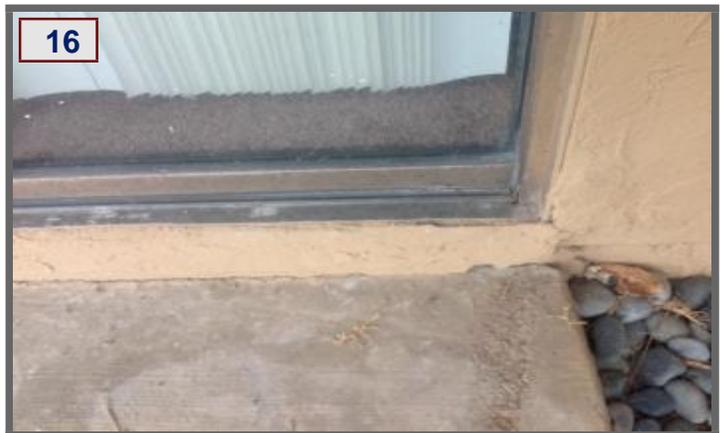
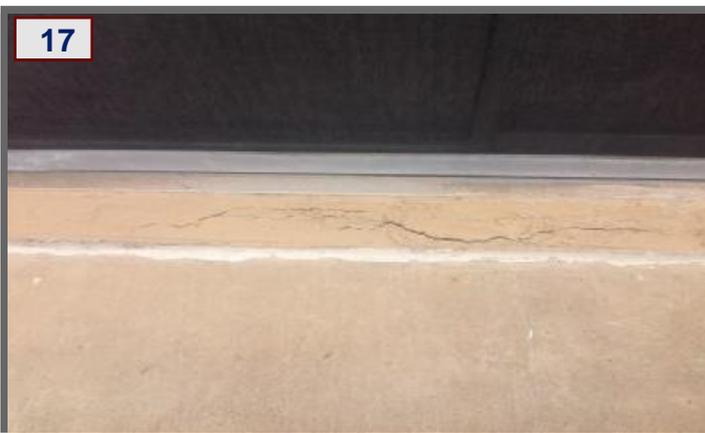
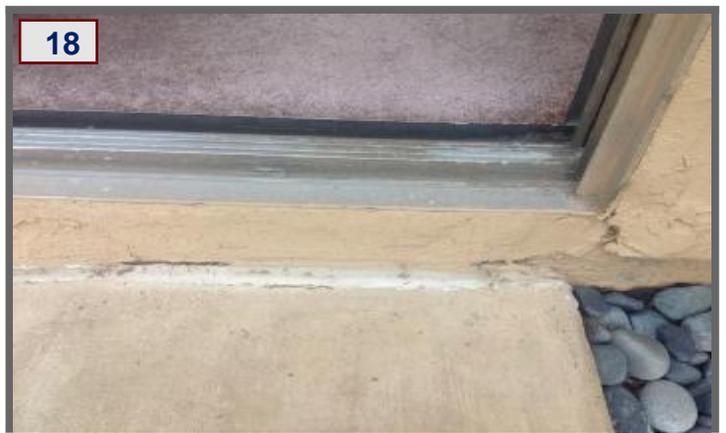
Stucco surface is cracked / damaged at several areas. See Photo # 15, 16, 1, 18 See Photo # 15, 16, 1, 18

Exterior Stucco Damage

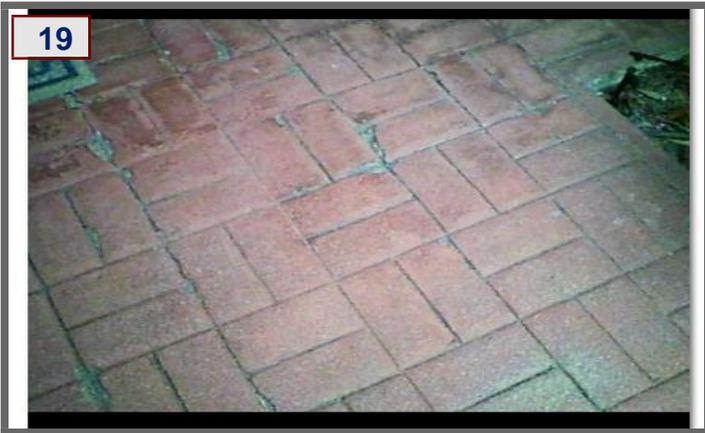
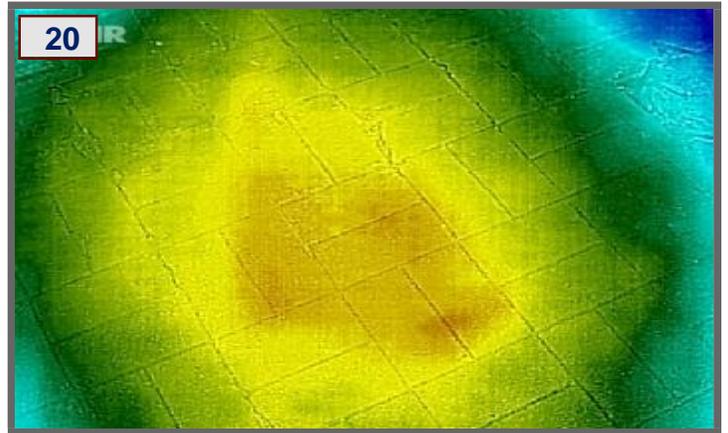
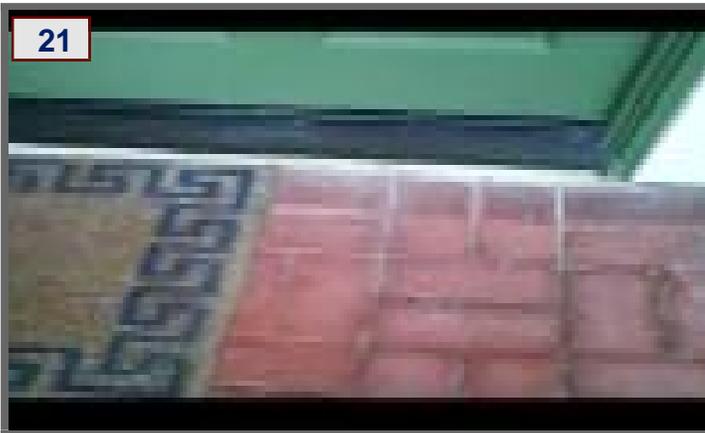
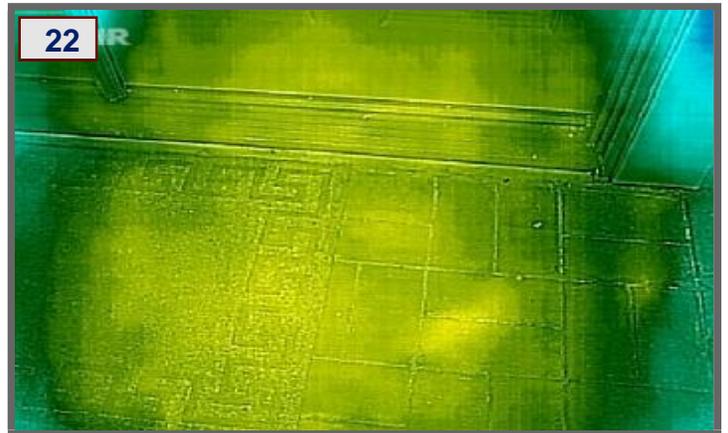
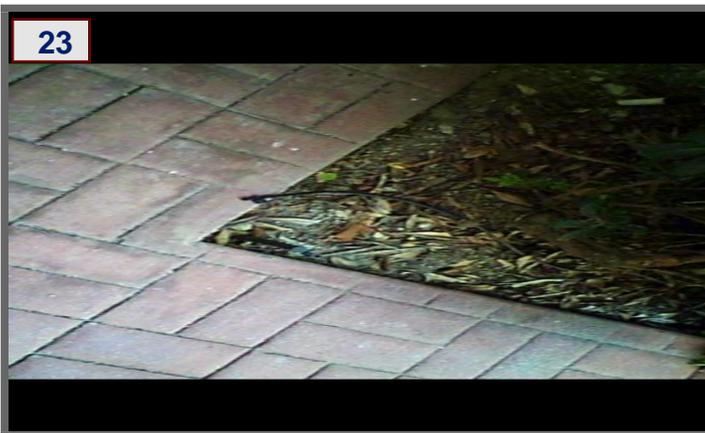
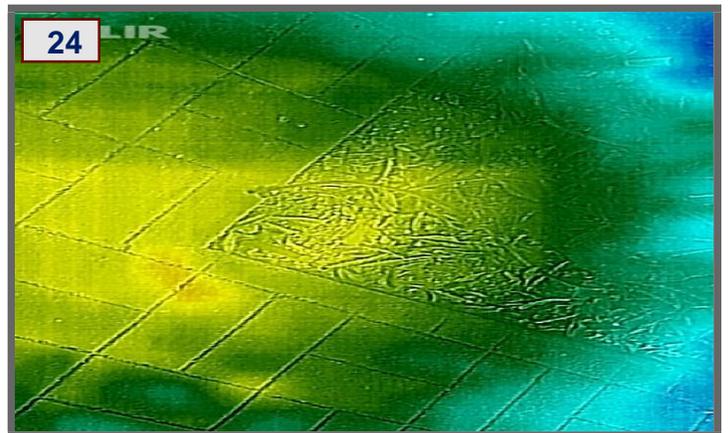
Moisture noted on Exterior brick Walk way, Recommend redirecting water for greenery.

Front Entry Exterior Moisture Noted
Recommend to Redirect Watering

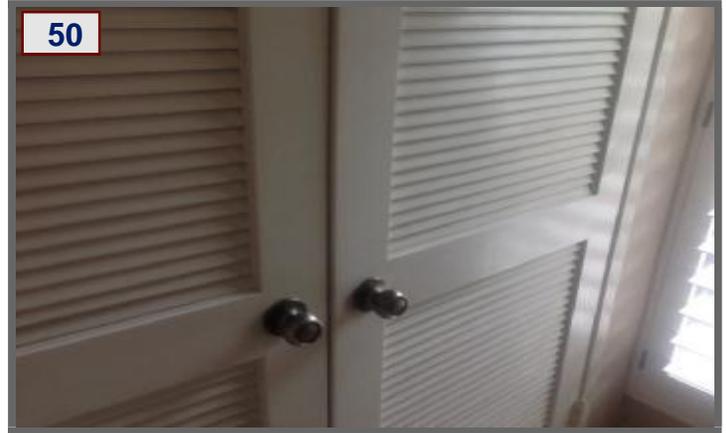
Entry hall Closet Doors will not Stay Closed

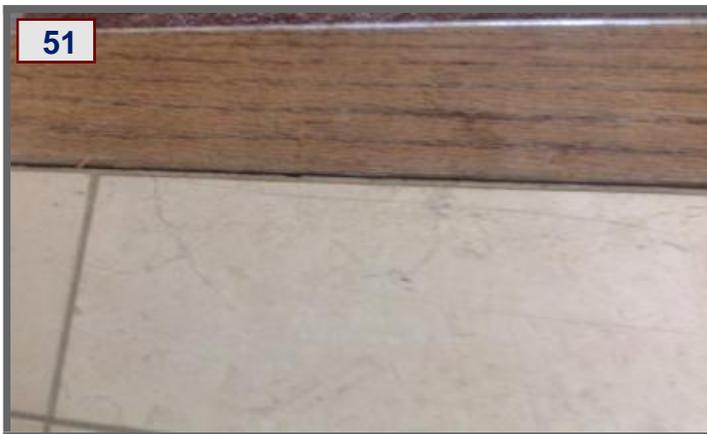
Entry Hall: Danger: Trip Hazard, Hall Entry To Down Stairs See Photo # 51

Danger: Trip Hazard, Hall Entry To Down Stairs

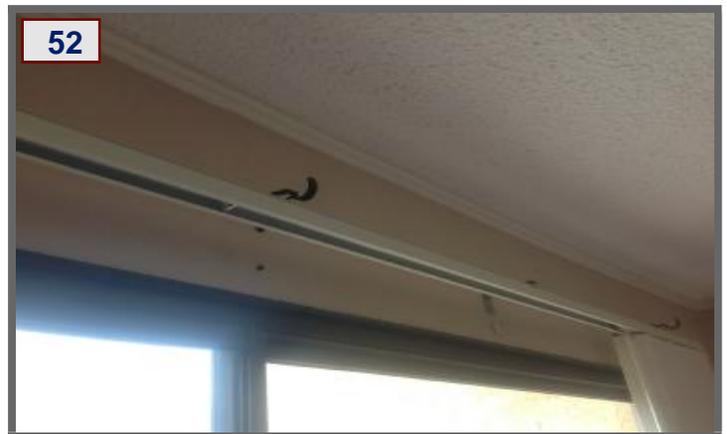
Bedroom # 2 Bedroom 2: Wall above Sliding doors Needs Repair, See Photo # 52

Bedroom 2: Wall above Sliding doors Needs Repair

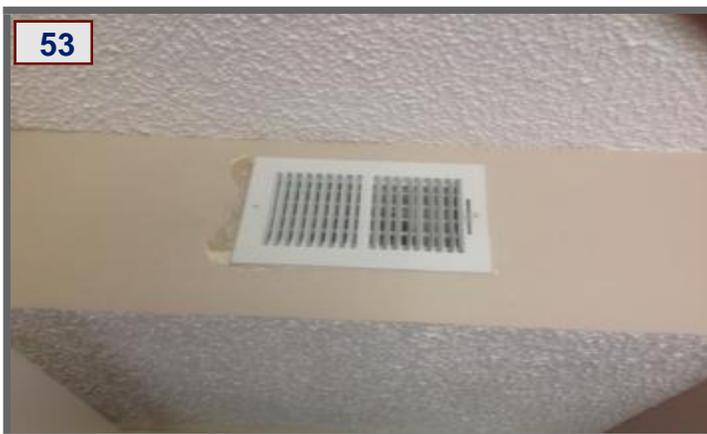
Bedroom # 2 Heater Vent, Wall damage See Photo #53

Damage Noted at Vent

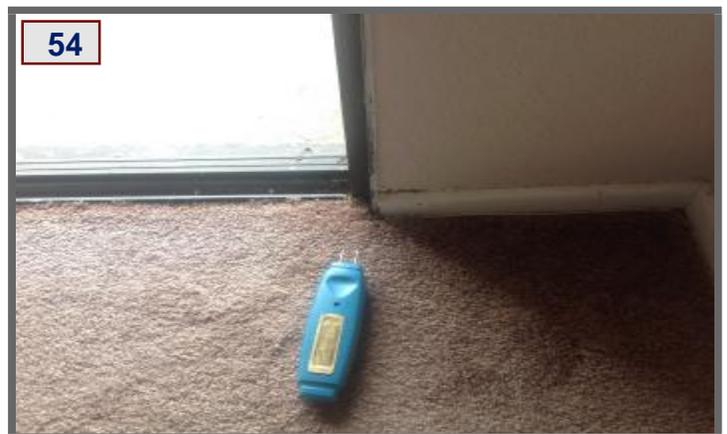
Bedroom # 2 Moisture Noted at Sliding glass Door. See Photo # 54

Moisture Noted in Carpet at sliding Door Bedroom 2

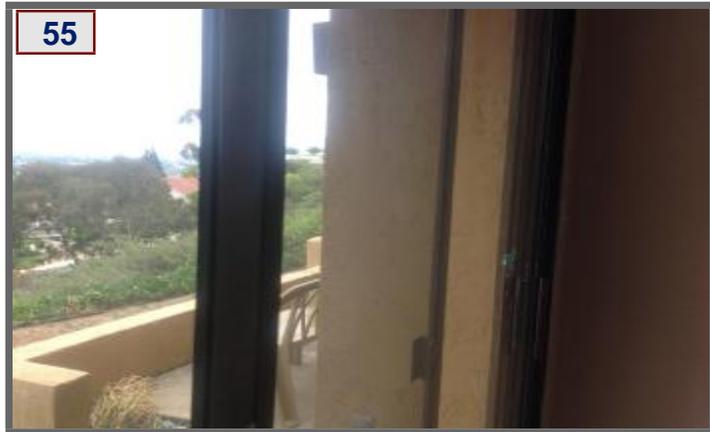
Bedroom 2 Sliding Door Hits Door When Closing

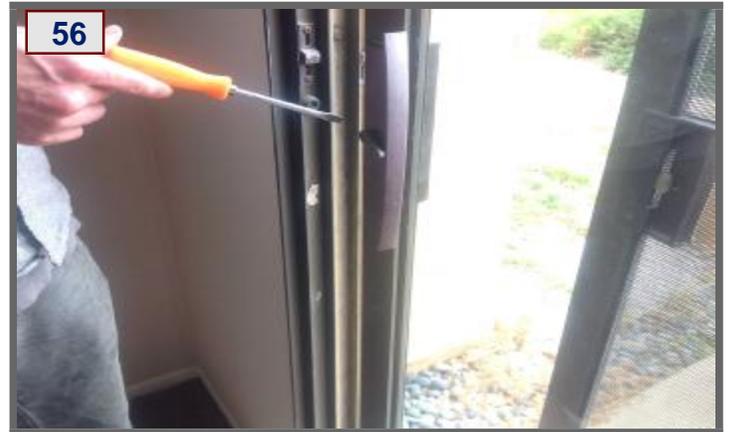
Master Bedroom: Sliding door hard to open and close and will not Lock. Needs repair/ Replacement. See Photo # 56, 58

Master Bedroom Sliding Glass Door Will Not Lock Hard to Open or Close

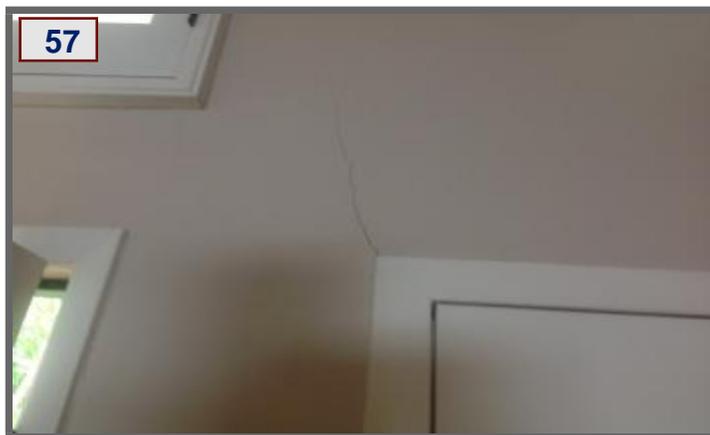
Entry Hall: Cracks Noted On Wall above Garage Entry Door. See Photo # 57

Crack at Enter hall Above Garage Entry Door

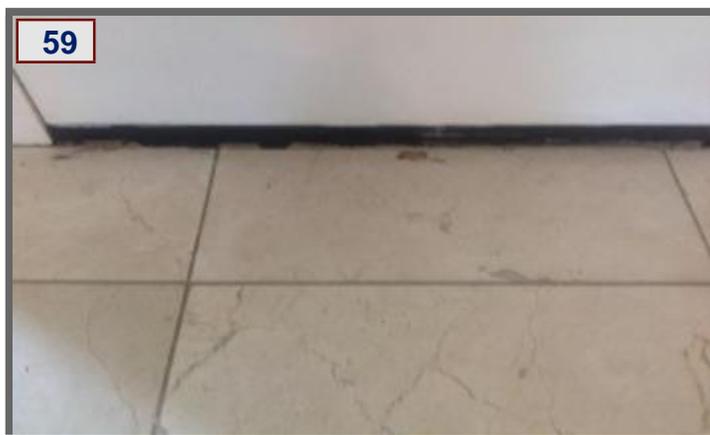
Entry Hall: Floor Damaged at Bottom of Garage Enter Door. See Photo # 59

Damaged Floor at Garage Enter Door

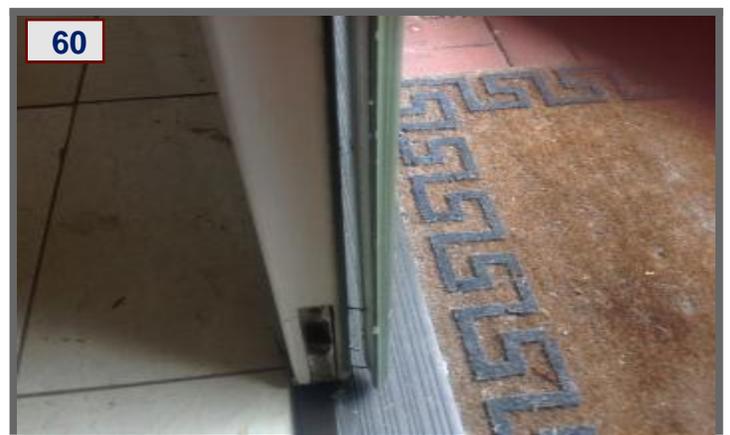
Entry Hall: Entry Door Damaged, Molding Damage. See Photo # 60

Front Door Molding

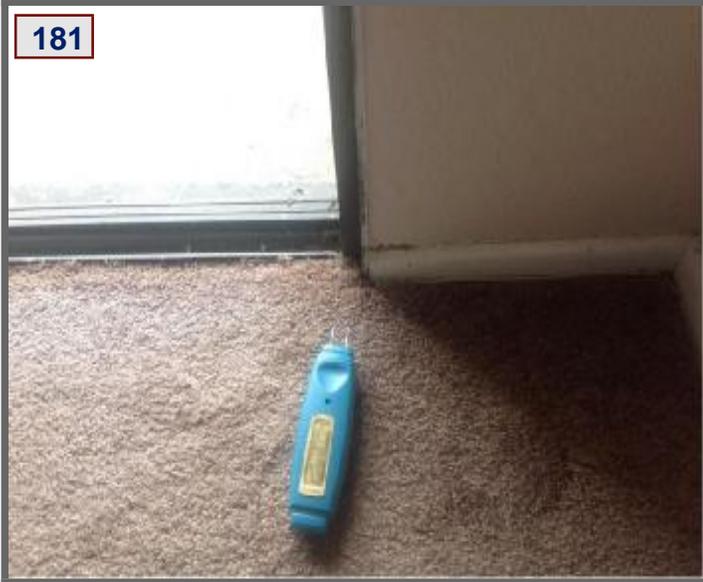
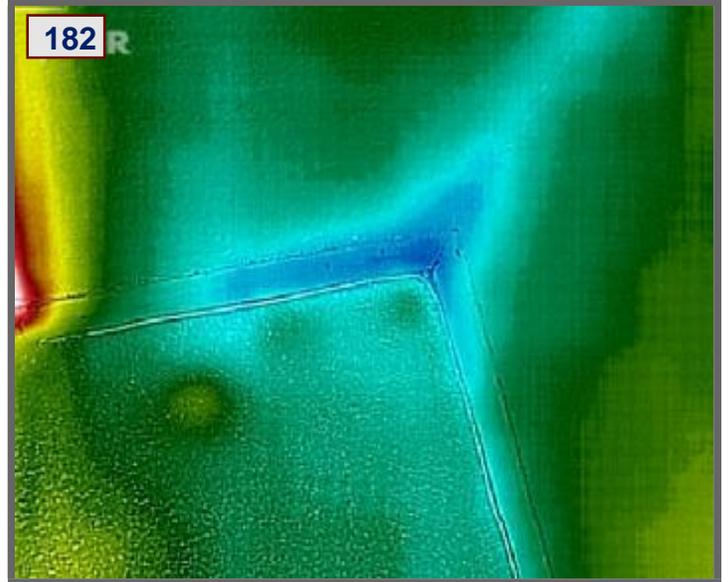
Right side of Sliding Door
Moisture Noted (2)

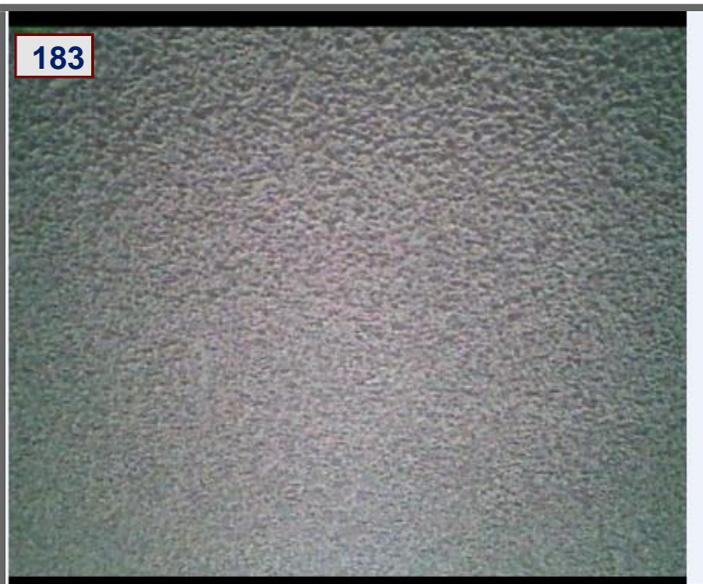
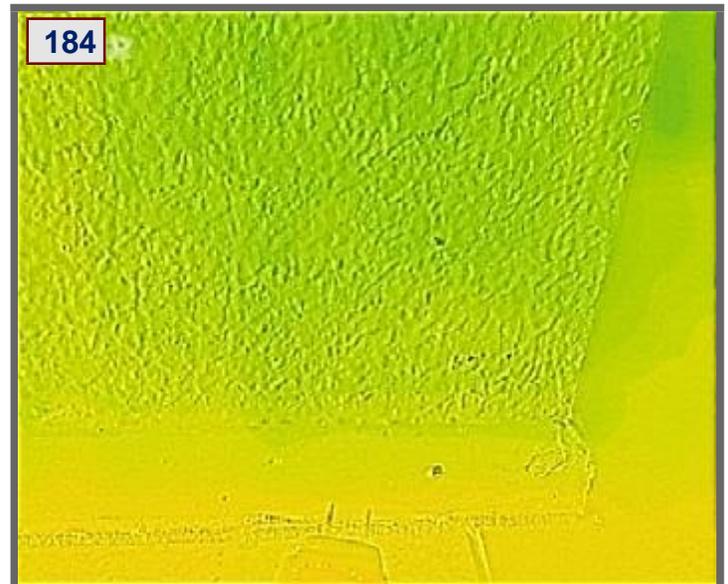
Ceiling Repaired in Bedroom 1
No Moisture Noted

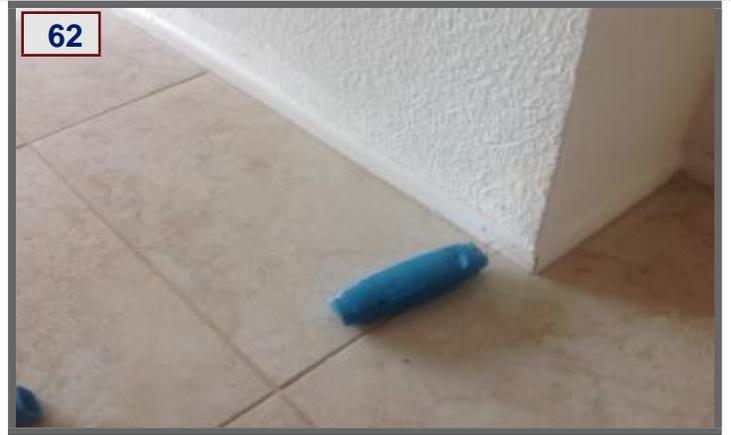
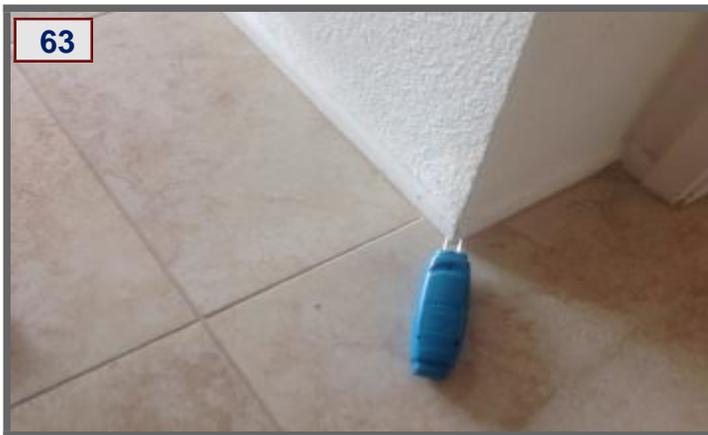
Kitchen in Wall Moisture Noted With Moisture Probe in Several Areas. See Photo # 62, 63, 64, 65

Kitchen in Wall Moisture Noted With Moisture Probe

Kitchen in Wall Moisture Noted With Moisture Probe , Kitchen in Wall Moisture Noted With Moisture Probe

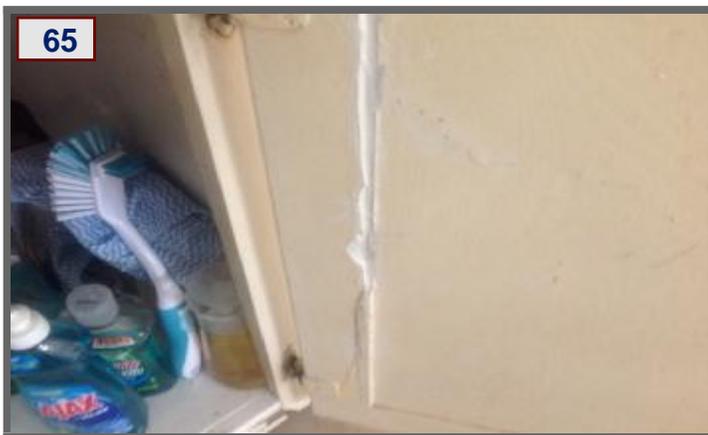
Cabinet Door Under Sink Damaged See Photo # 65

Damage to Kitchen Sink Cabinet

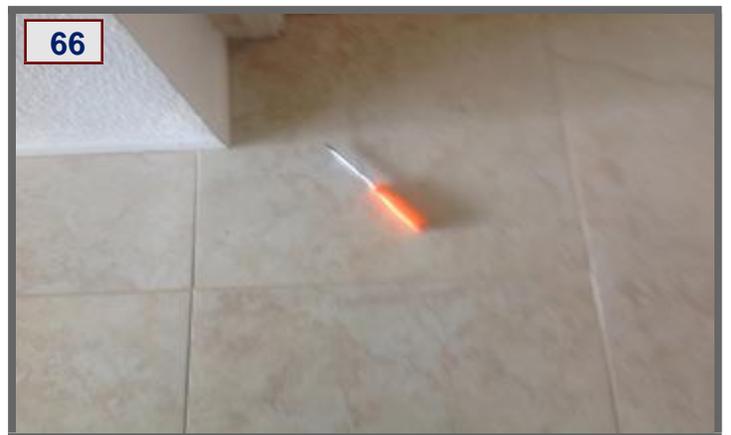
Floors: Tile is Not Sealed to Floor, May come Loose. See Photo # 66

Kitchen Tile Not sealed to Floor

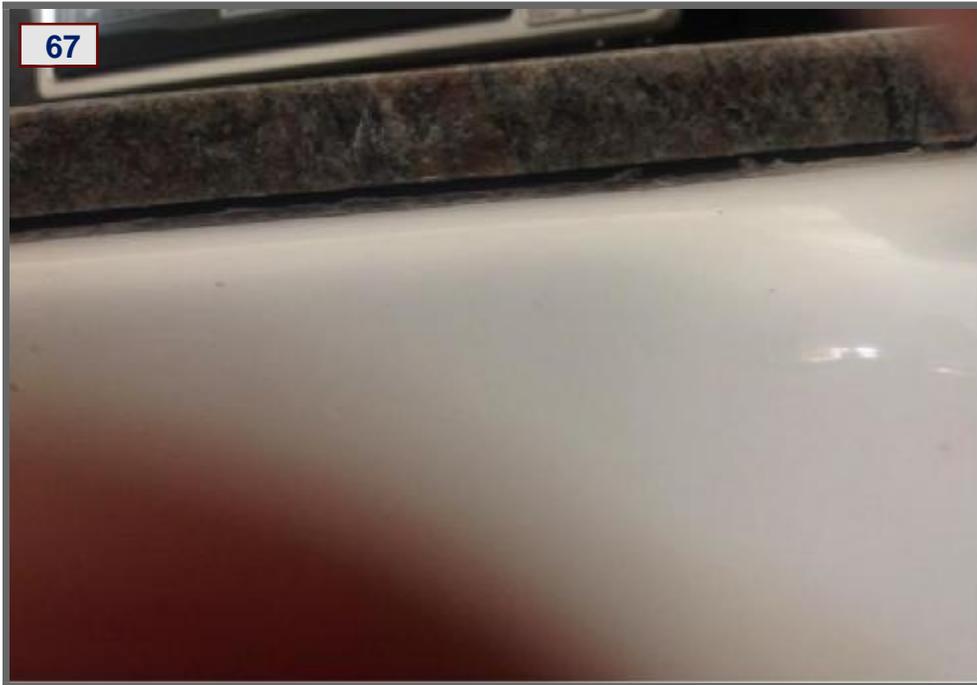
Gap Noted at Kitchen sink, Needs Calking to prevent Water Damage. See Photo # 67

Gap at Kitchen and Garnet

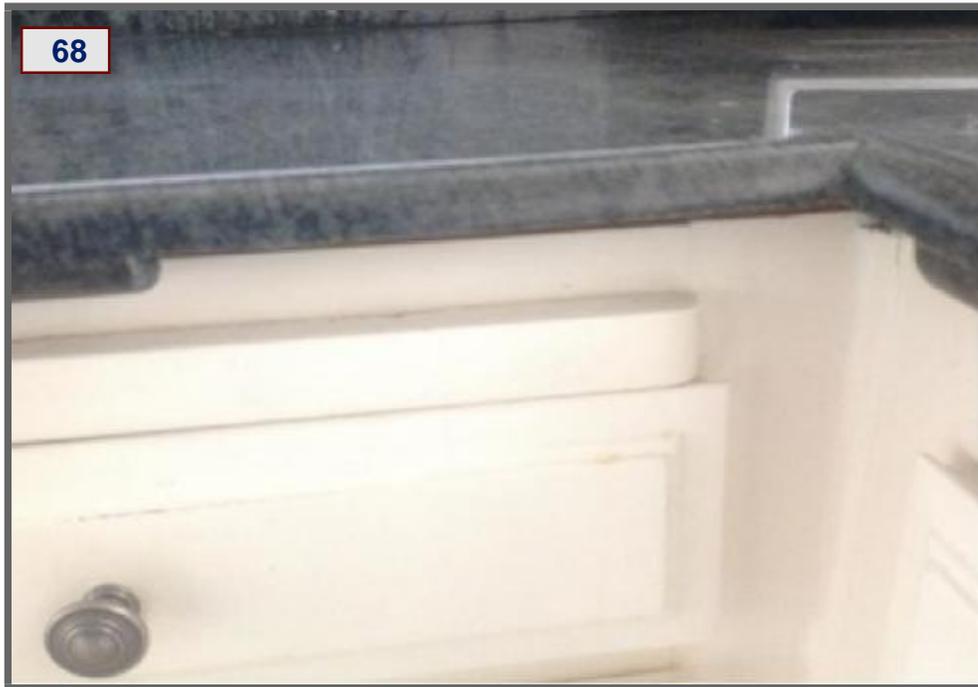
Damaged Garnet Counter Top at Left of Sink, Missing Quarter Round. See Photo # 68

Damaged Garnet at next to Kitchen Sink

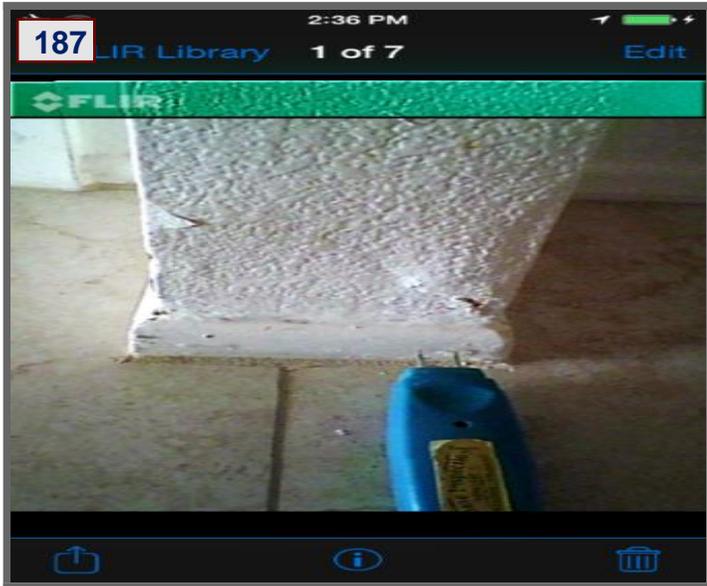
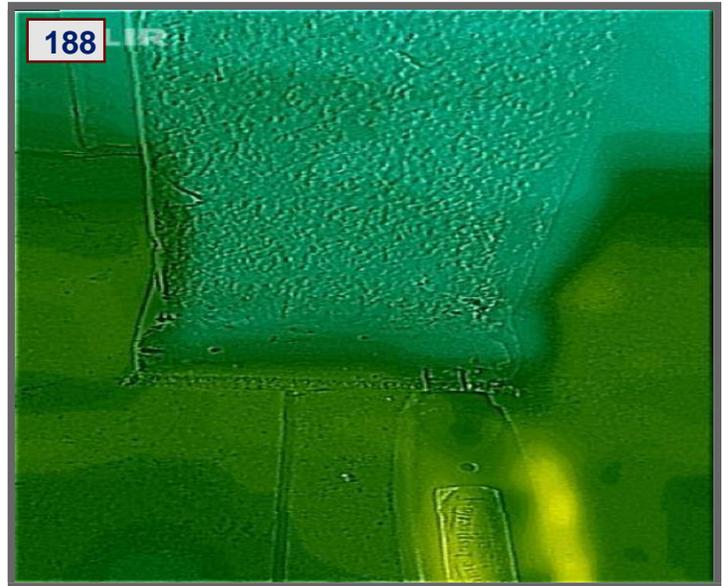
Kitchen Moisture Noted in Several Areas

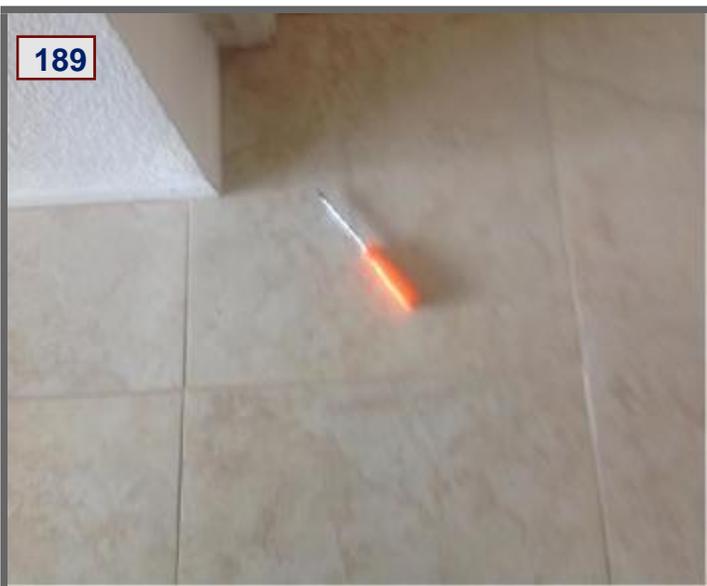
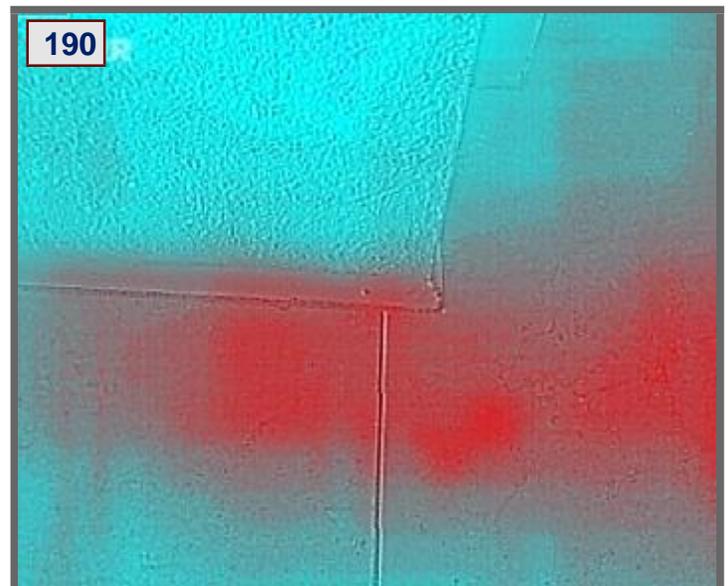
Loose Tile And Moisture Noted

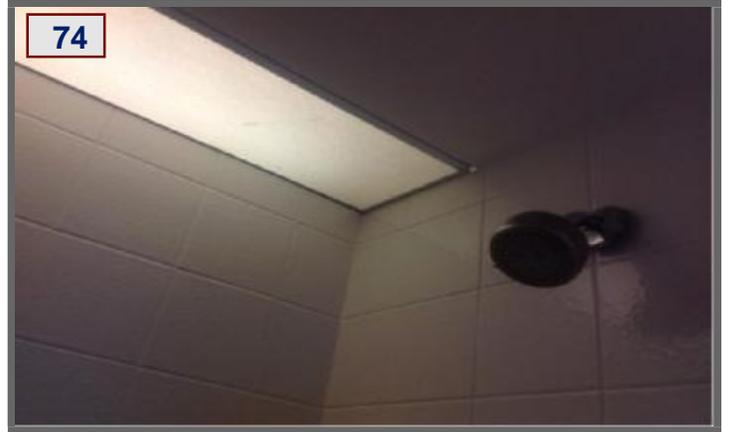
Master Bath Electric Light Not In Code

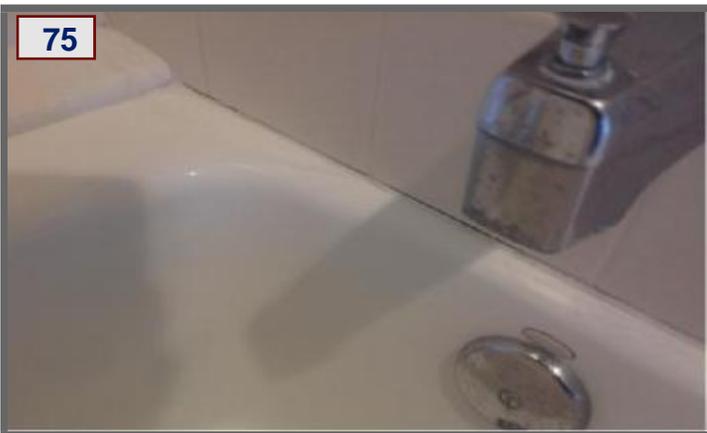
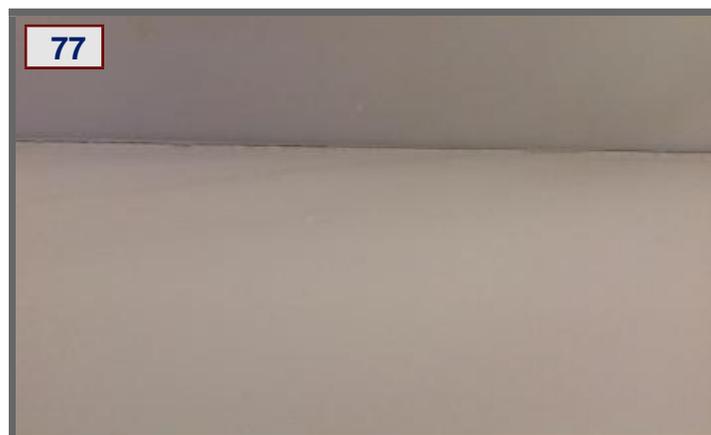
Both Bathrooms need Re-Calking Around Bath Tub, Sinks and Counters

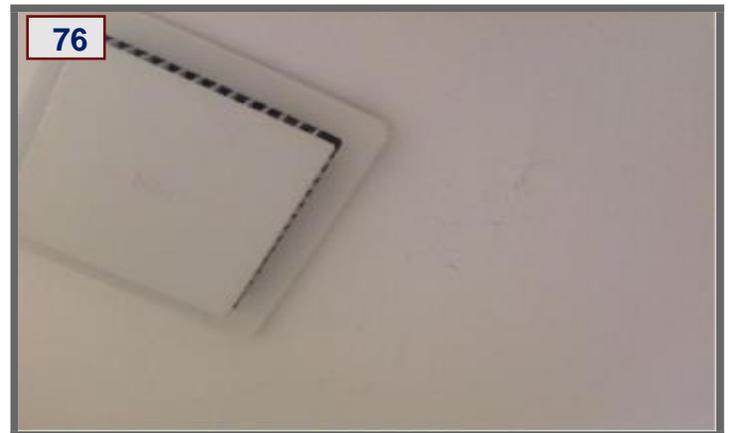
Upstairs Bathroom 1/2 Bath. Fan Needs Repaired/Replaced, Makes Lots of Noise. See Photo 76

Entry Hall 1/2 Bath Exhaust Fan needs Repaired/Replaced

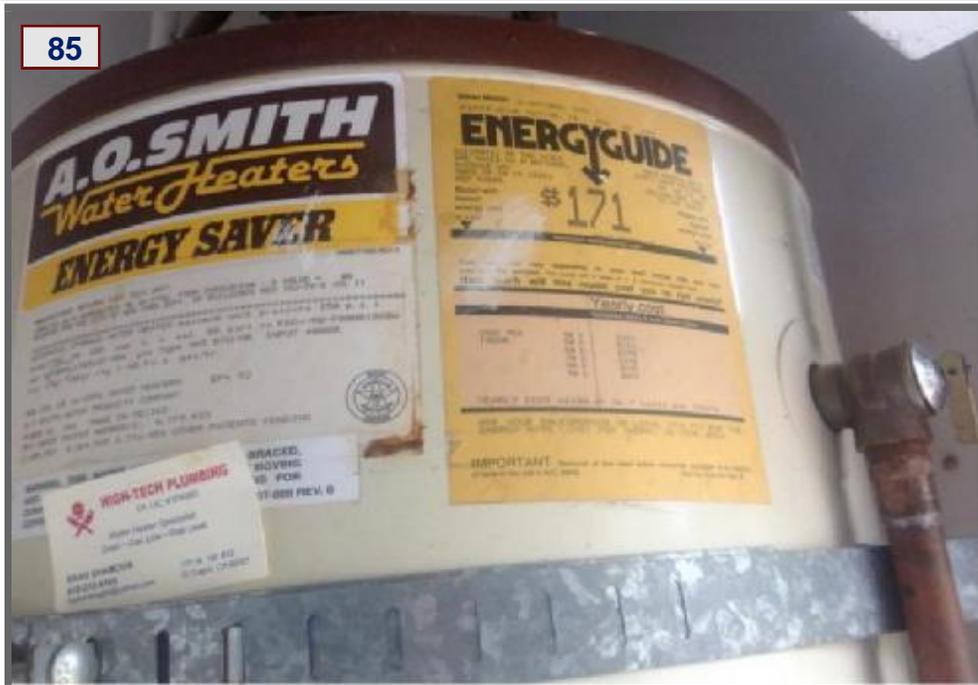
Hot Water Heater Rusted

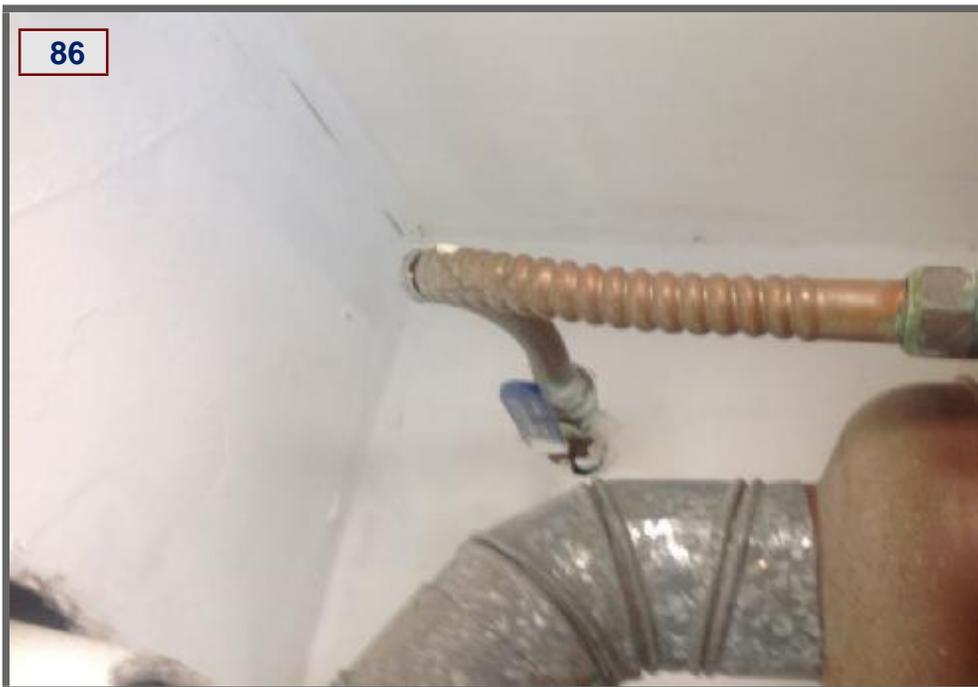
Water Heater: Hot Water Heater Shut off Valve Corroded . See Photo # 86

Hot Water Heater Shut off Valve Corroded

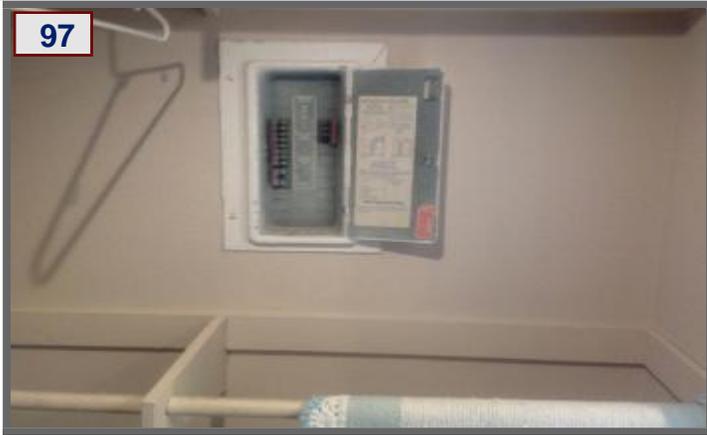
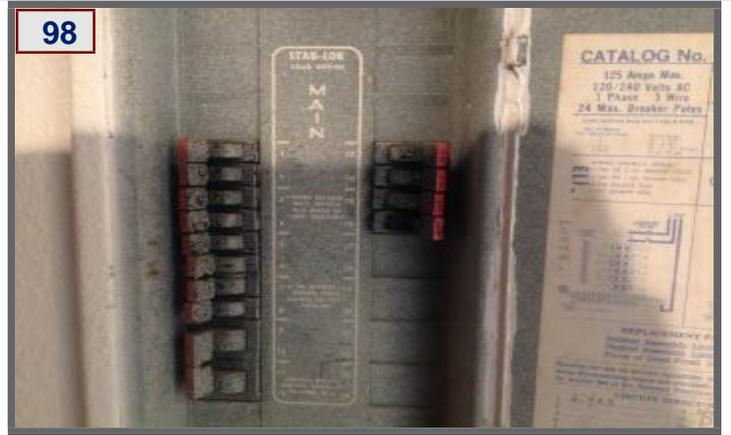
Stab Lok Main & Sub panels and circuit breakers manufactured by Federal Pacific are suspected of having design flaws which can allow them to cause shock hazards and fires. We recommend replacement of these panels. Note also that electricians may not work on this equipment, and replacement parts may be difficult to find and expensive. See Photo # 97, 98

Main Electric Panel

Recommend evaluation or repairs by a Qualified licensed contractor / specialty trades person.

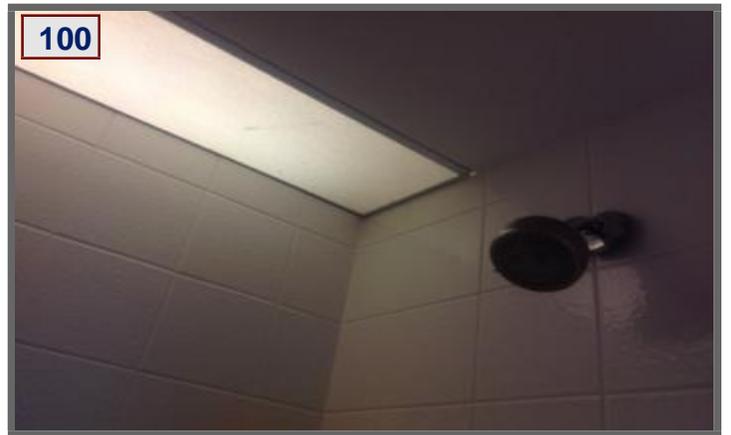
Light In Master Shower
Not To Code

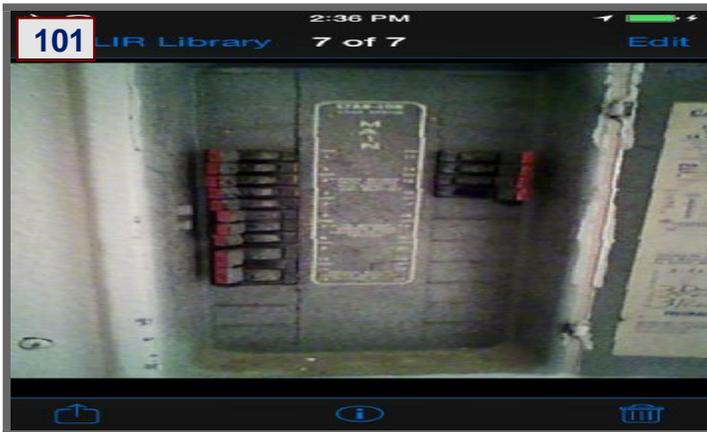
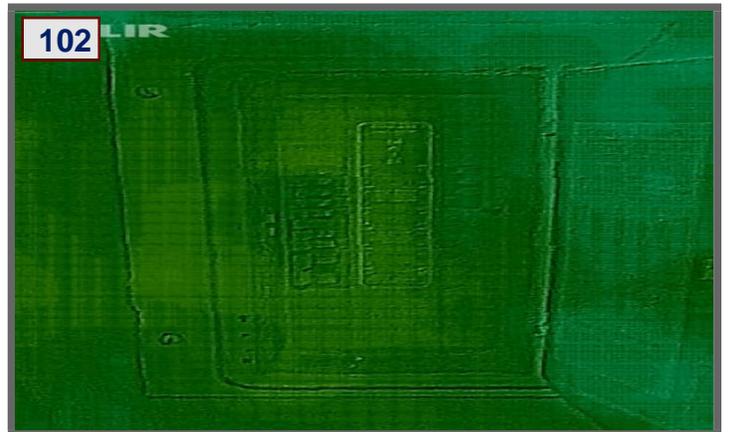
Electric Main Panel In Closet , No Hot spots Noted

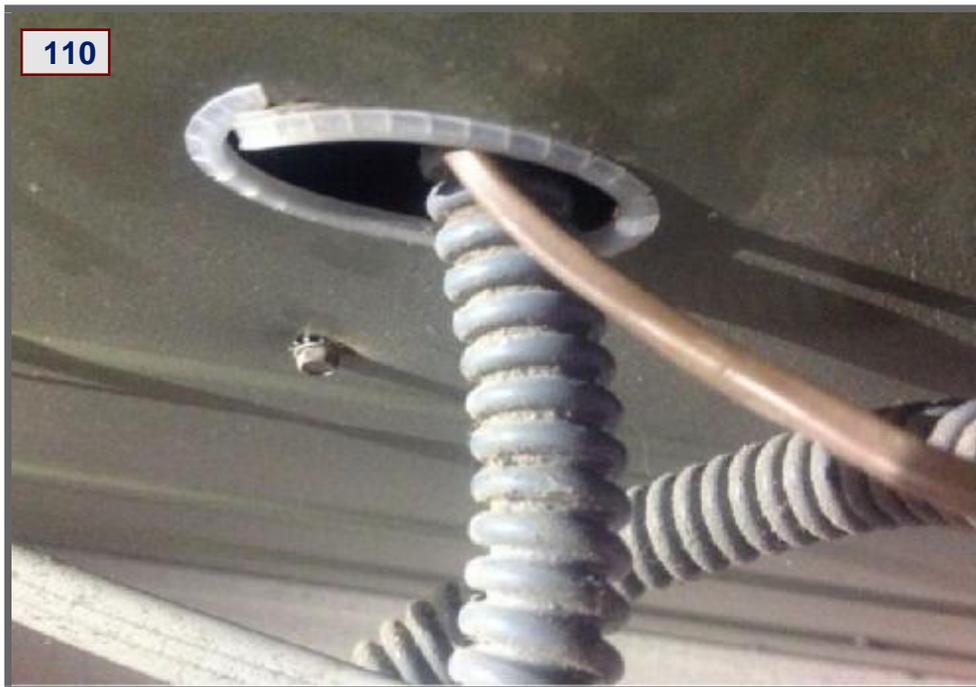
Gas Line In Properly Installed

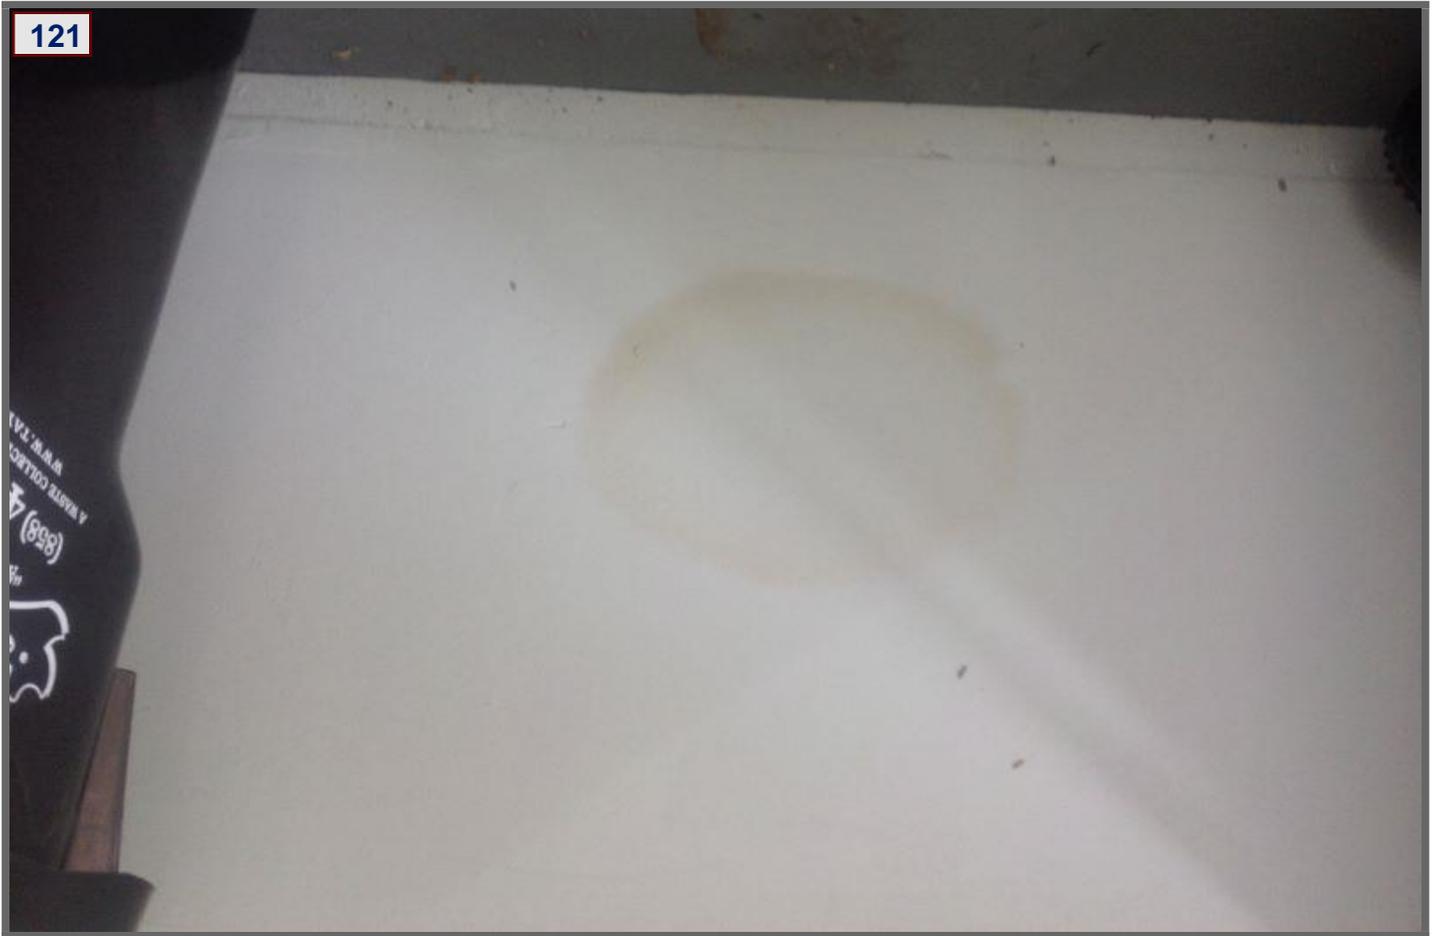
Garage Wall: Stain on Wall. Cuttently Dry, Unable to determine Ware it Came From. See Photo # 121

Water Stain
