Report # / I.D : Samp070612

Inspection Date : July 12 2012

Property Address : 411 Circle Caviar, Murrieta, Ca, 92562

Type Of Inspection: Pre-Purchase Inspection

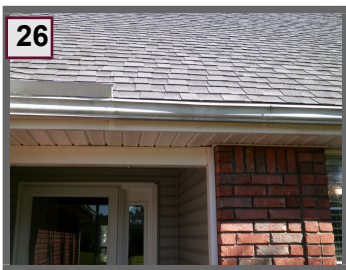
View of trim that needs secured

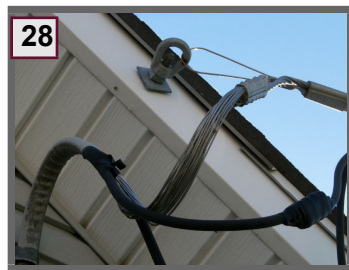
View of elect over garage

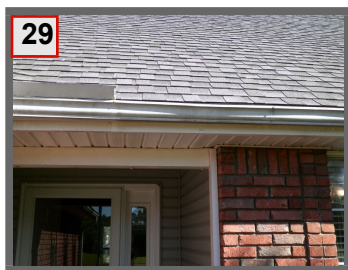
Shingles showing signs of weathering & age.

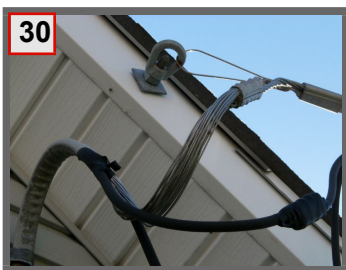
Wire in over hang
